**Appendix (b) Section 19  
December 2013 East Coast Surge**

This document was produced by the Environment Agency to be appended to the 'Section 19 Investigation Report - Overview of coastal surge flood event during 5th, 6th & 7th December 2013'.

## Section 19 Appendix (b) Final Report – August 2014

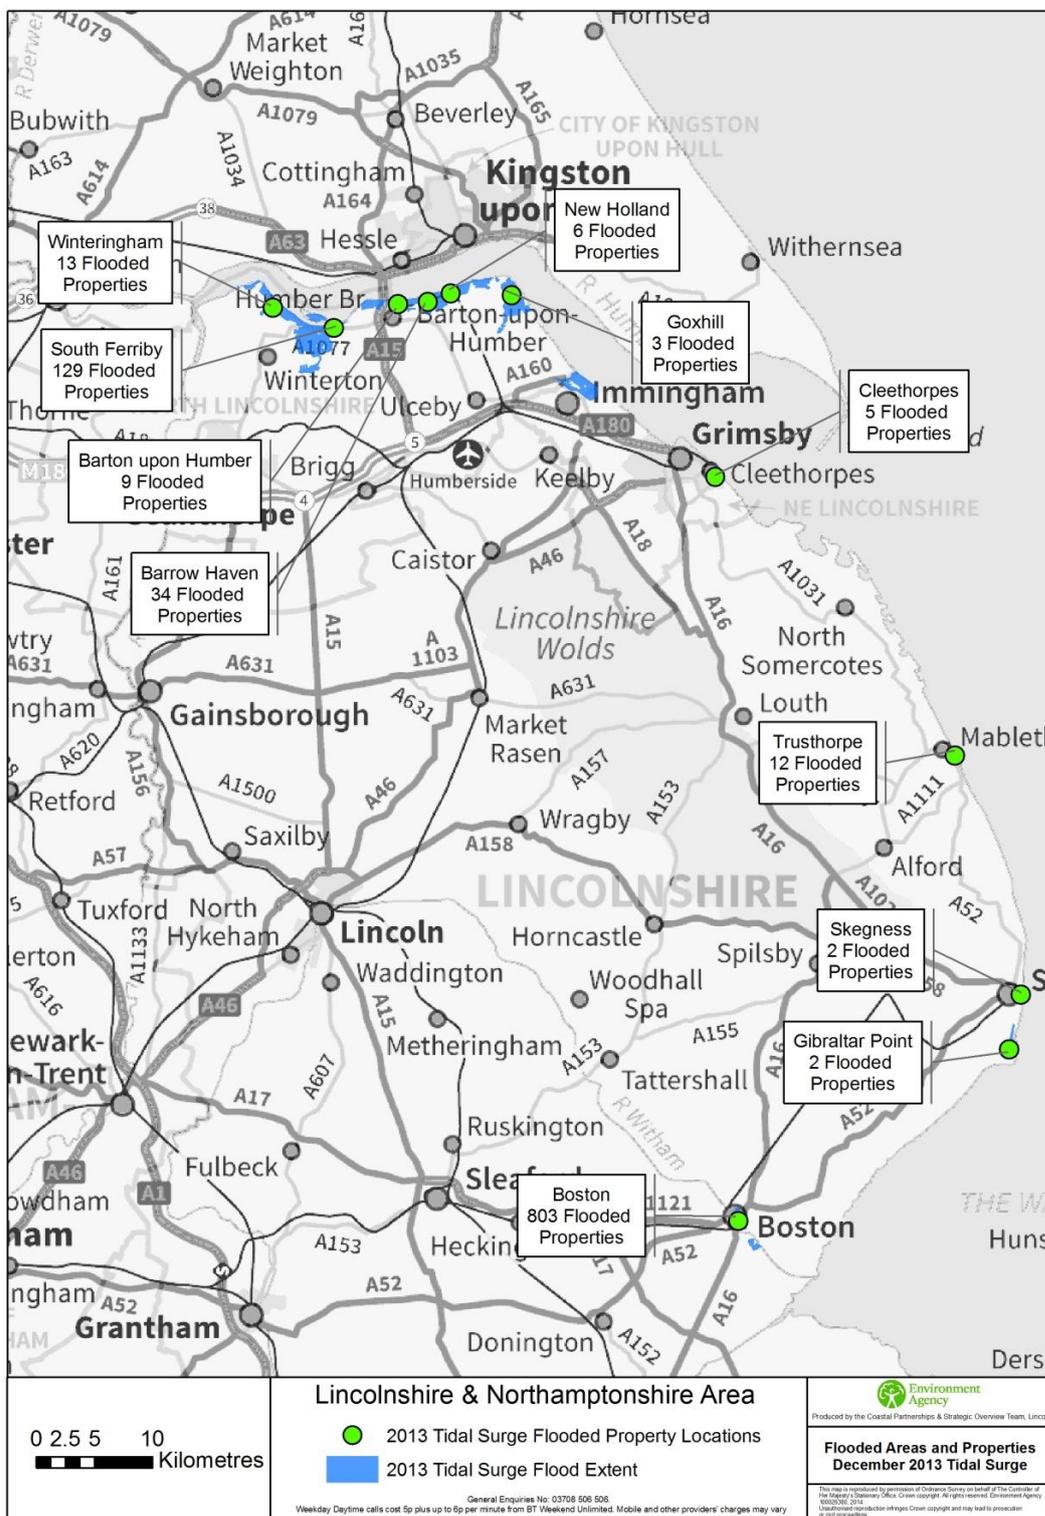
Figure 1 – Properties flooded during December 2013 in Lincolnshire and Northamptonshire Area

This section details the extent of the flooding and the associated impacts. Figure 1 below demonstrates the distribution of the flooded properties along the East Coast showing that the South Humber Bank and Boston were locations that were significantly affected.

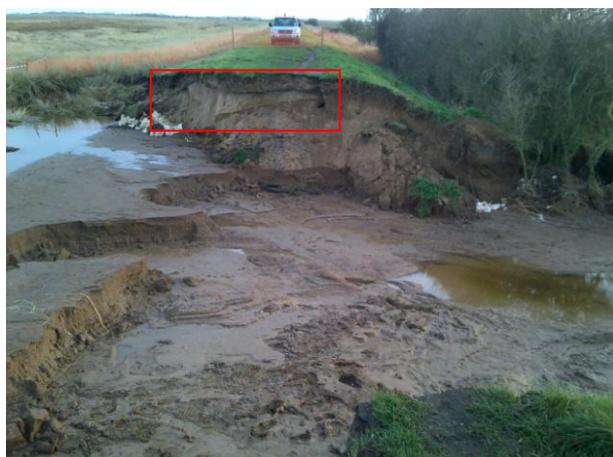
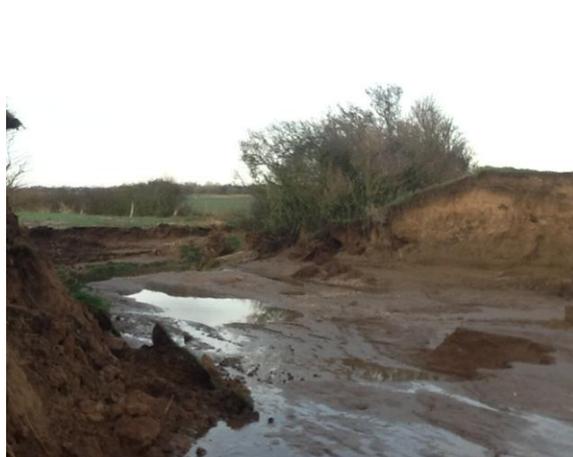
The initial surge on 5 December 2013 damaged the earth embankment and as a result of the high tide on Friday morning a breach occurred. The banks consist of local materials, mostly sand and estuary alluvium.

The eroded material from the breach was washed into the adjacent local Internal Drainage Board system at the rear of the bank. From here most of the flood water ran southwards into the Louth Canal, upstream of Tetney Haven sluice. This led to short-term and localised flooding to approximately 20 hectares of arable land, together with raised water levels in the ditch network through the caravan park. This dissipated within a few hours. The threshold of the breach was slightly below the saltmarsh foreshore and within the normal tidal range of spring tides.

Breach at Tetney Marshes.

The repair of this breach was a priority as the bank reduced flood risk to 188 residential and 12 commercial properties, an oil storage depot and an Anglian Water Waste Water Sewage Works.

As a precautionary measure ahead of the predicted tides on 15 December, a small earth bund, within the breach, was constructed on 14 December to give some protection in the event that there was another tidal surge. Work to affect a full repair started on 16 December and was completed on 23 December in time for predicted high tides around New Year.

The repair work involved the transportation of approximately 3000 tonnes of material by road and then to site by tracked dumper along 2km of existing raised flood bank to the breach. The work was undertaken using a local Environment Agency Framework.

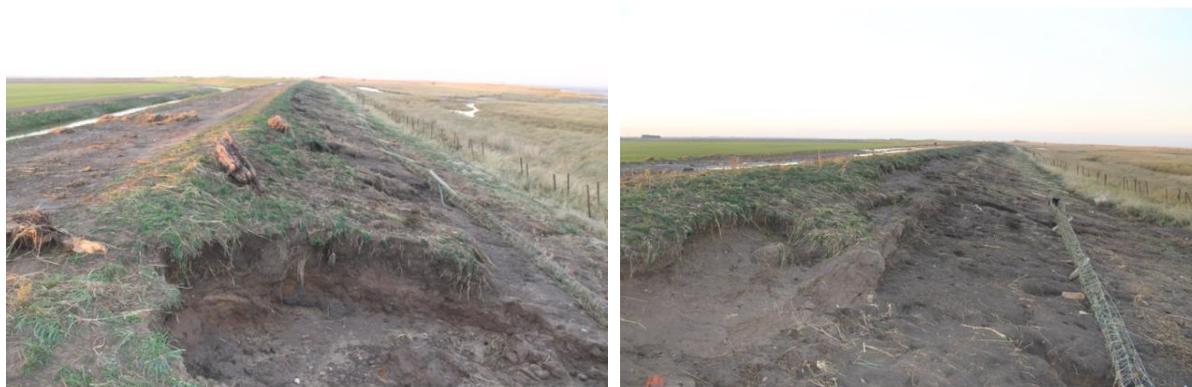
While no properties or agricultural land were affected, the defences were damaged over a length of 400m. The majority of the damage occurred to the sandy areas along the seaward face of the defence embankment up to a maximum depth of 0.6m. It was evident the damage was limited to the areas of embankment where there was a narrower saltmarsh across the foreshore.

Damage to seaward face of embankment, primarily occurring up to the original crest level.

Where overtopping had occurred due to wave action, there was a limited amount of scour to the landward face.

We carried out initial repairs to this damaged section to ensure that the residual flood risk remains low. A further programme of works to complete a full repair will begin in August with an estimated cost of £110k.

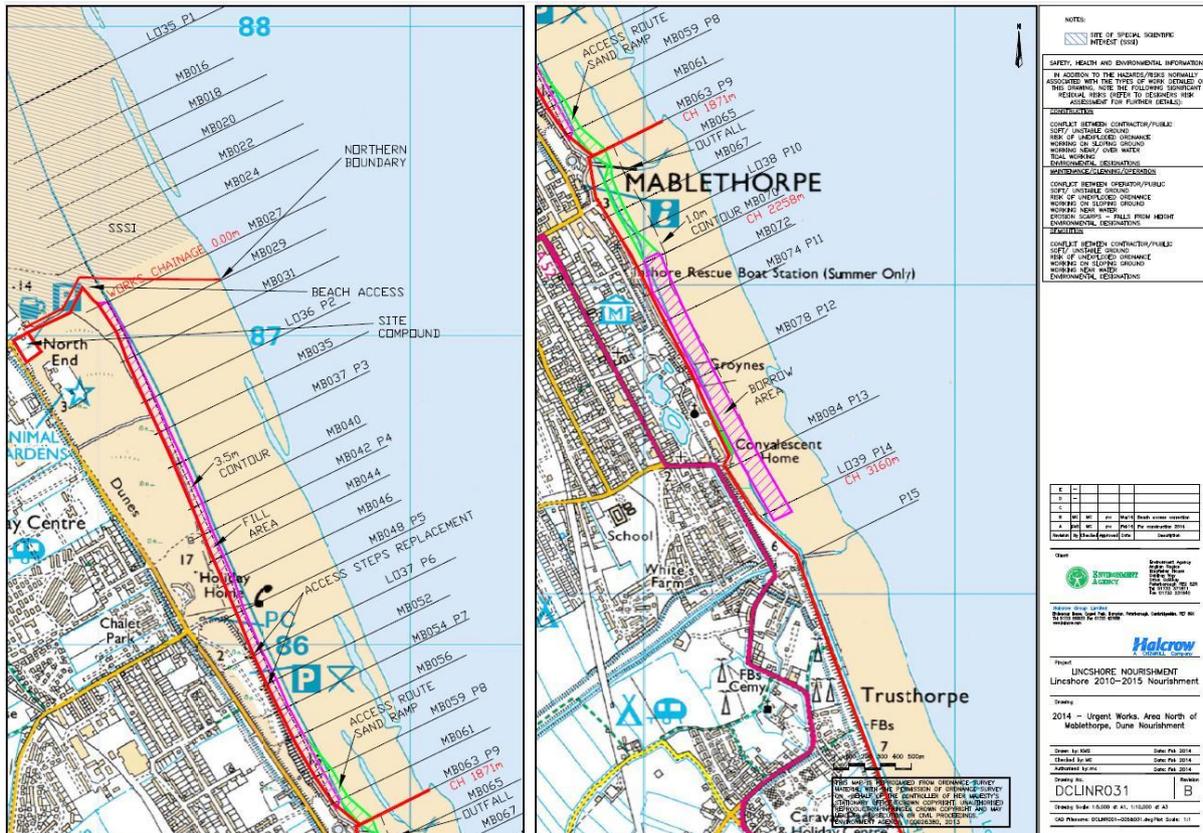
Current estimates of beach losses are 55,000m<sup>3</sup> between transects MB027 and MB063 (see detailed plan on page 8). This volume is based on differences from the newly formed beach profile to approximately 100m seawards, over a shoreline length of approximately 2,250m.

Detailed plan of sand dune erosion area on the left and area used to borrow sand for the nourishment on the right.

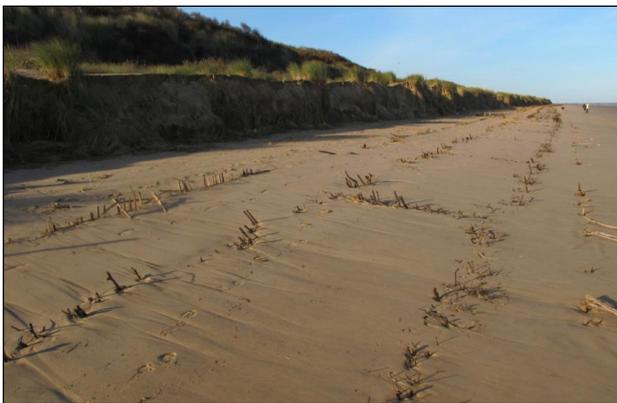
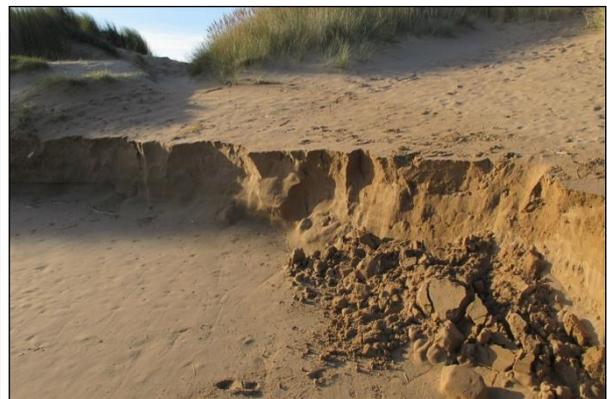
There were no properties affected by flooding, however the dune system north of Mablethorpe suffered considerable erosion.

Dunes to north of Mablethorpe- considerable amount of dune system washed away. The remains of the old fence lines can still be seen.

Following significant sand dune erosion north of Mablethorpe after the storm surge, emergency beach recharge and dune management has been undertaken to maintain the beach/dune system between Mablethorpe outfall and the southern limits of designated conservation sites. The works were completed in April 2014.

The emergency works consisted of replacing 55,000m<sup>3</sup> of material that was lost. £4.05 million was allocated to repair the damages in this area caused by the surge.

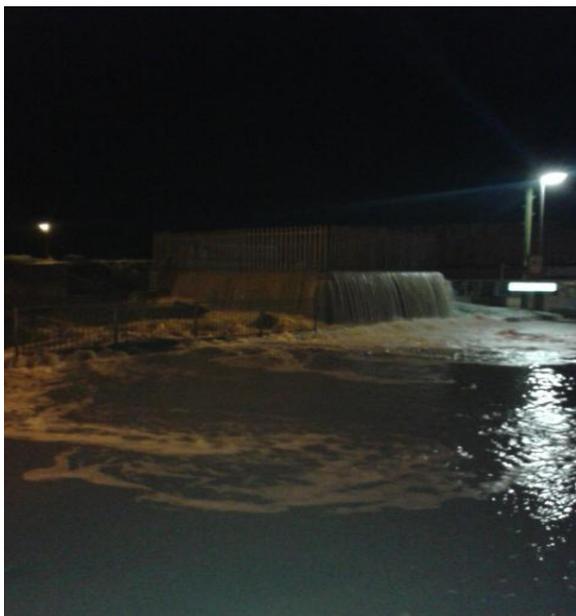
12 properties were affected by flooding in Trusthorpe. Water travelled up the surface water outfall through the non-return flap valve. The differential in water height

resulted in a large volume of water spilling out of the chamber into the surrounding area behind the defences – see photos below.

IDB chamber – photo Google

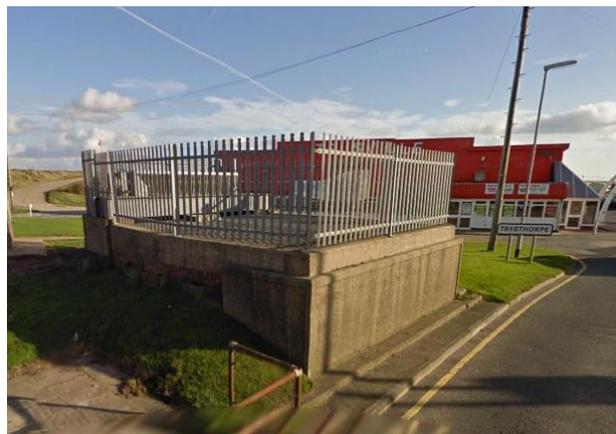
Overtopping of IDB structure behind Environment Agency defence. Looking south east across Seaholme road.

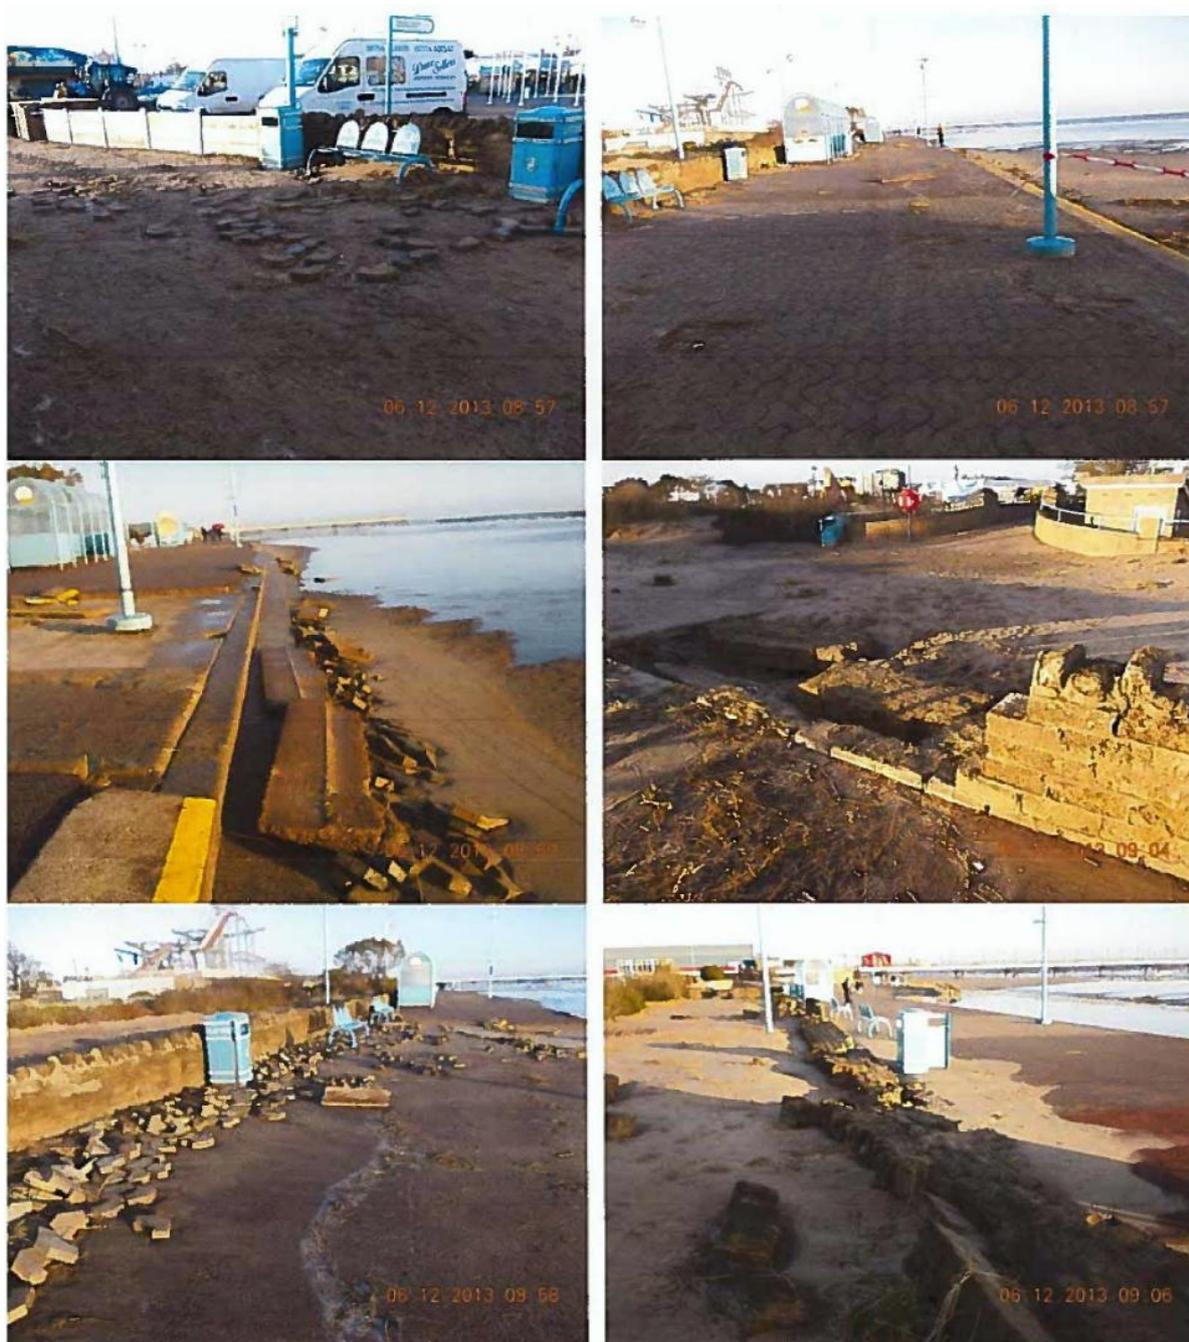
Photographs taken on 6 December by East Lindsey District Council

During the surge, the existing stone wall at the rear of Skegness promenade, between the clock tower and pier, collapsed in a number of places by wave action upon the wall.

Temporary defences were put in place by the Environment Agency's emergency work force to prevent further flooding in the short-term. Discussions are currently under way with East Lindsey District Council to agree Partnership Funding for a permanent solution.

This work to construct a permanent flood wall will be undertaken as part of a local regeneration scheme in October.

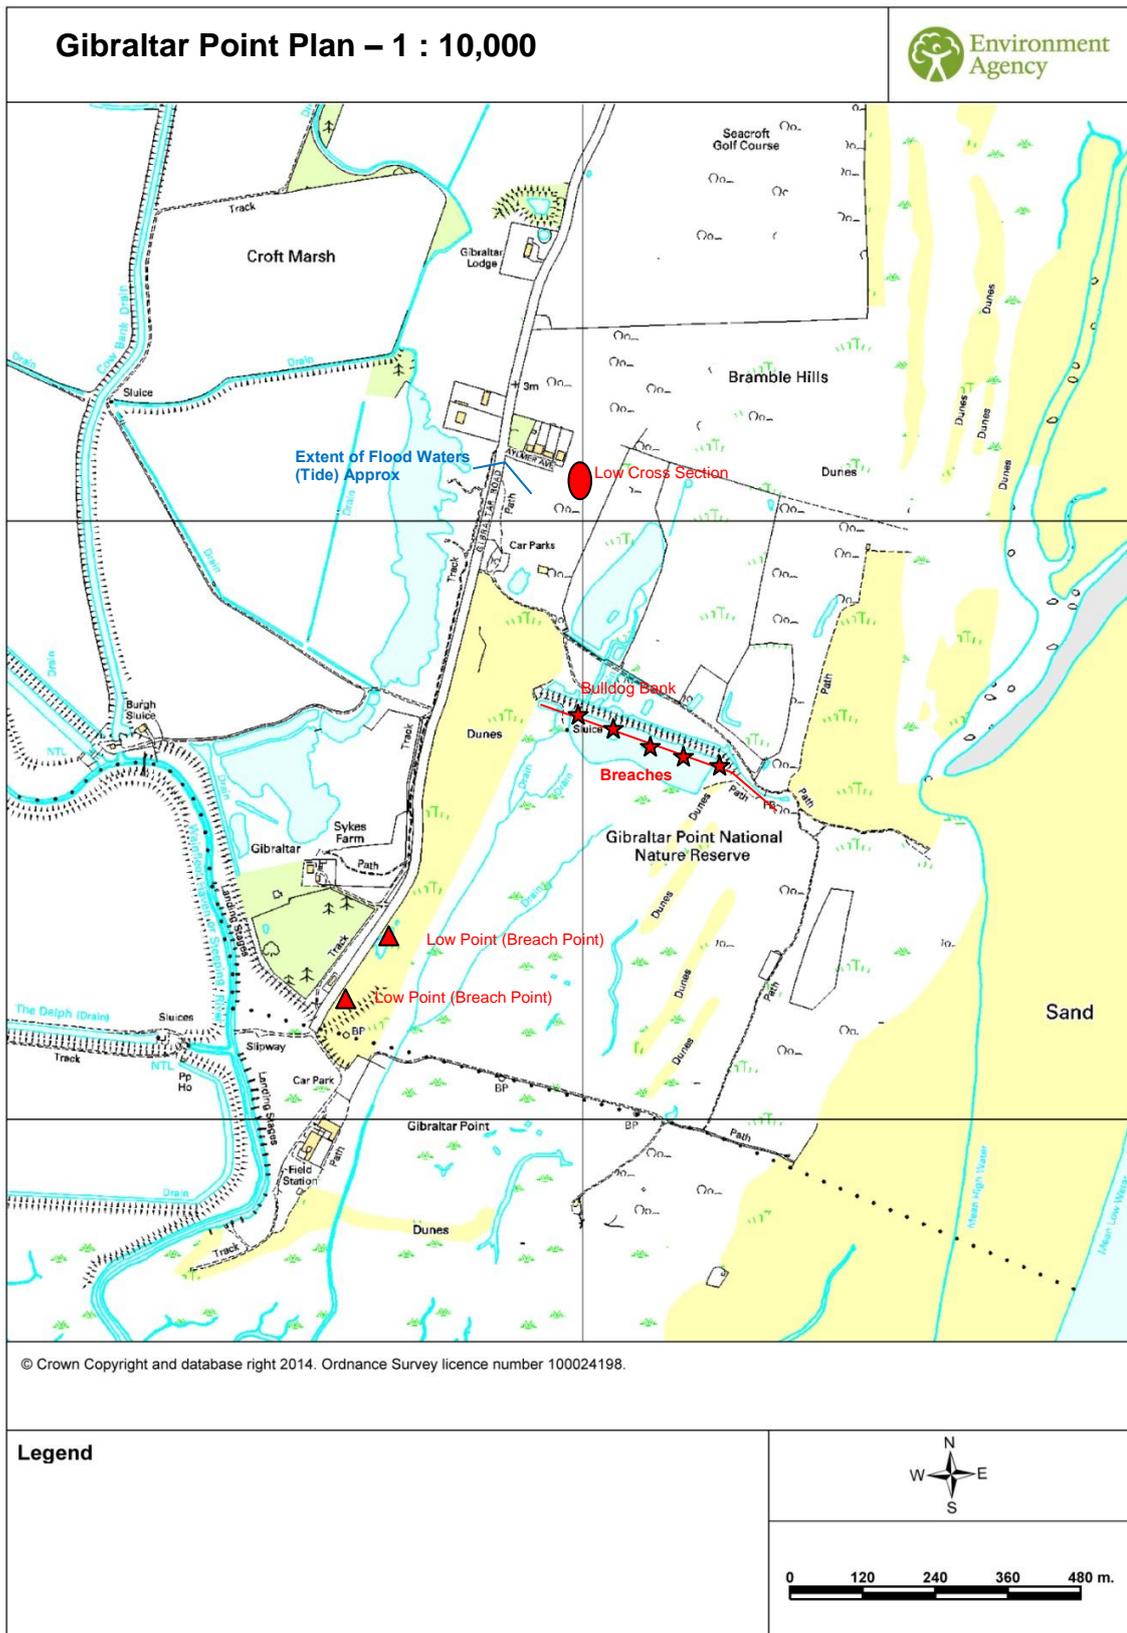
On 5 December, the water level came over the primary tidal defence, Bulldog Bank, which runs east to west across the Lincolnshire Wildlife Trust site at Gibraltar Point. This bank separates the freshwater part of the site on the north from the saline marshland side to the south (see site layout on page 12). The flood waters inundated the visitor centre and the attached annex property, occupied by the Wildlife Warden. These properties are located on the tidal side of the flood defences. There are a number of other properties on the inland side of the defences that could be affected by the flood waters. Access routes to houses became inundated and parts of the golf course to the north of the wildlife reserve suffered from flooding.

The flood waters encroached (see plan above) into the nature reserve (marshland) area and began to overtop Bulldog Bank sea defence. This caused erosion across the top of the bank and subsequent breaches occurring.

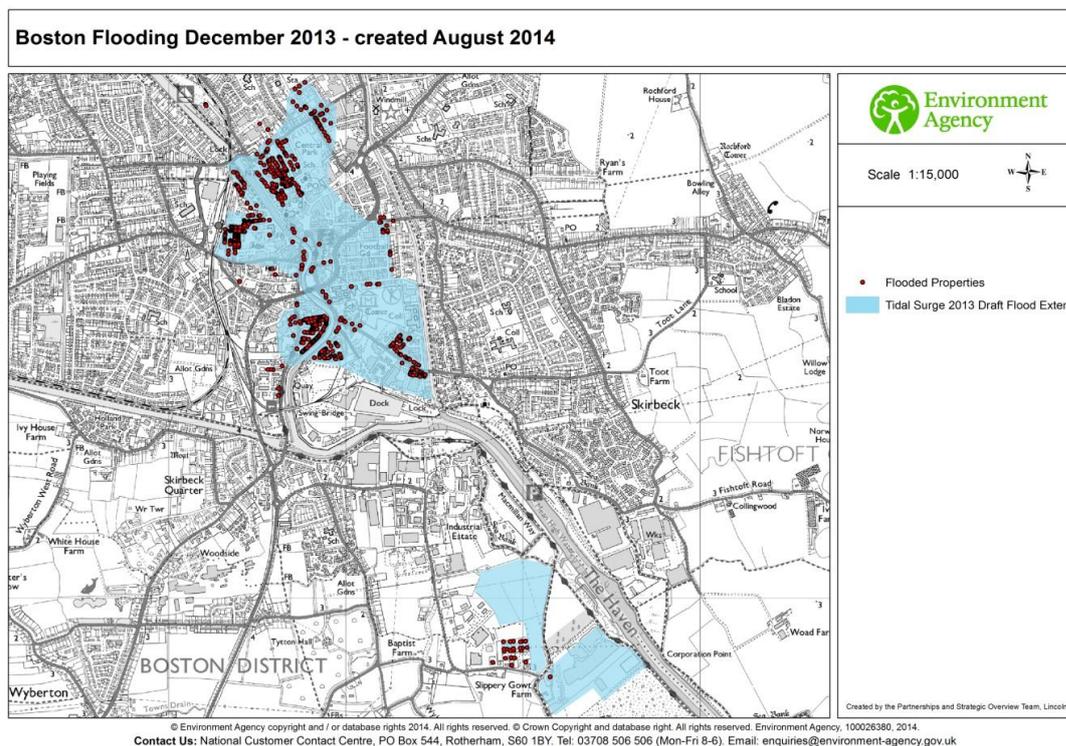
On the evening of 5 December 2013, at approximately 6.30pm, water levels exceeded 5m in the Haven and the positive pressure on the flood defences resulted in seepage at various locations through the town between Black Sluice Pumping Station and Grand Sluice. As the tide continued to rise above 6m, around 7pm, the majority of the flood defences throughout the town over-topped and continued to do so until levels started to recede an hour later. The large volume of water resulting from seeping and over topping of defences inundated the areas shown in the flood extent map above.

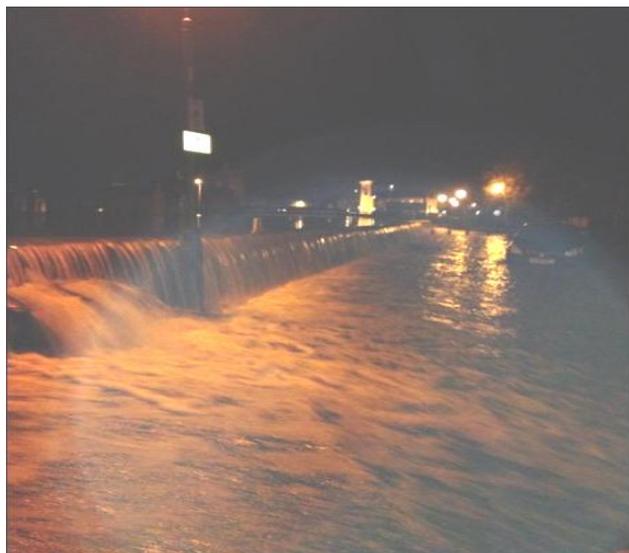
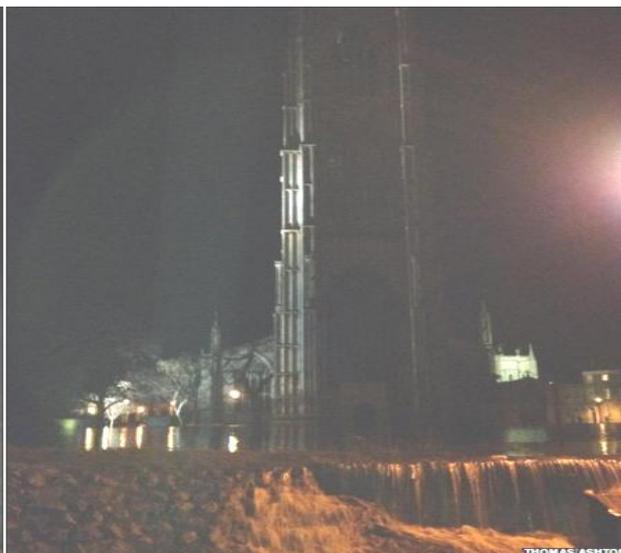
The walls of The Stump (right hand picture) recorded the height of the 1953 flood. The water marks from the December surge are well above these.

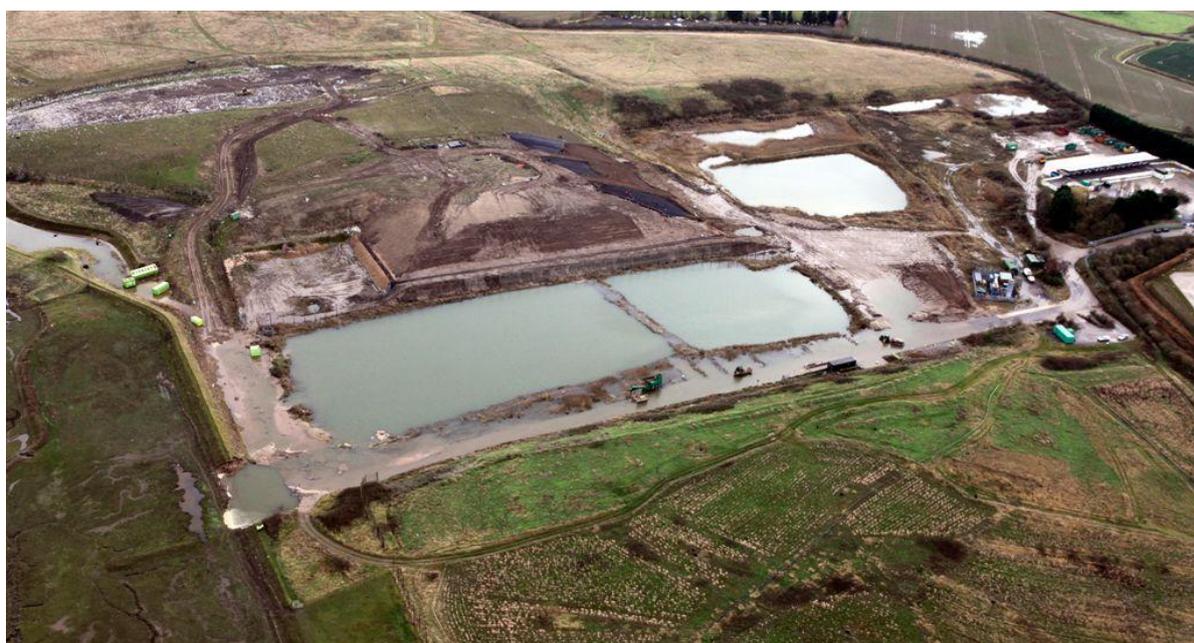
During the surge, the primary defence line (earth embankment) was breached to a width of 30m to 40m, flooding the landfill lagoons behind. Flood waters overtopped at a couple of low spots and through an open culvert in the old sea bank. This flooded neighbouring farmland and properties, mainly commercial, on the Haven Business Park off Marsh Lane.

Slippery Gowt - picture taken on 6 December 2013.

Following the 40m wide breach at Slippery Gowt, an immediate temporary repair was completed during December to secure the defence. We used 300 tonnes of stone with 3m sheet piles driven along the front face. The contractor worked 14 hour days, using floodlights to allow them to work in darkness, to ensure the works were completed as quickly as possible (cost to date £140K). A permanent repair to improve defence stability will be undertaken in October and November 2014.

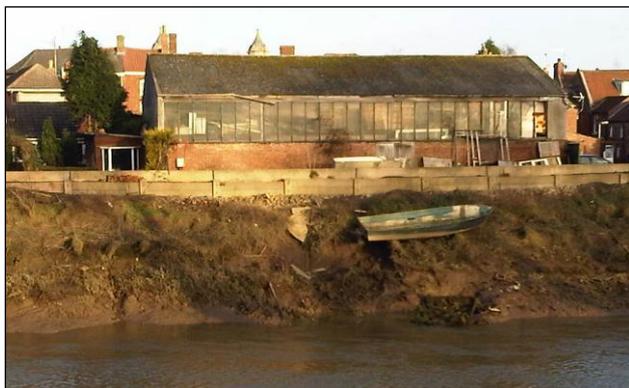
Bank slippage - Boston

This area, just downstream of Grand Sluice on the left bank of The Haven did not show signs of movement following the 5 December tidal surge. The first signs of movement followed the New Year high tide

This area, just downstream of Grand Sluice on the left bank of The Haven started to show signs of movement following the New Year high tide and required 300 tonne of stone to be placed along the toe of the bank to prevent further slippage. This work was completed by the end of March 2014.

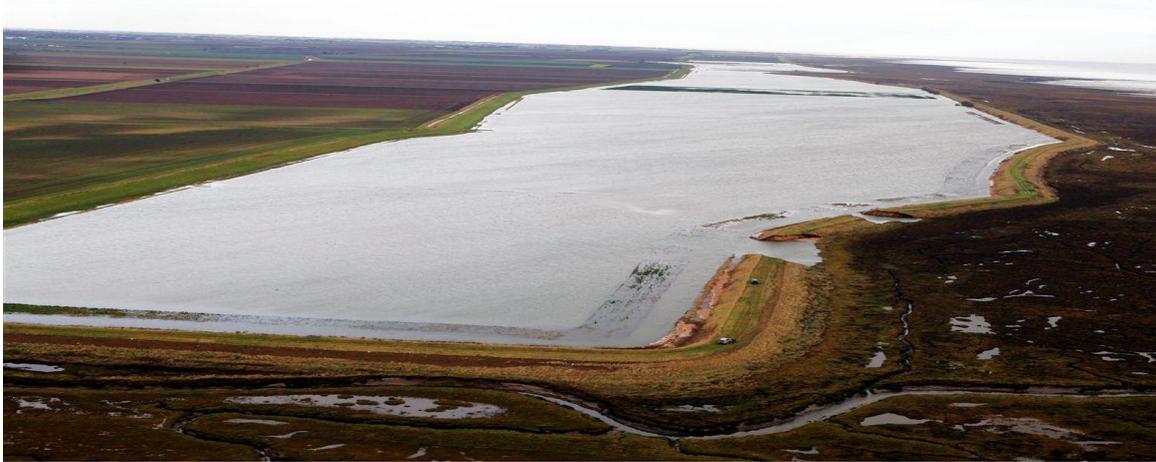
The tidal surge on 5 December 2013 caused the 1977 private line to breach in 2 separate locations (approx breach width 30-40m each) resulting in approximately 200 ha (500 acres) of grade 1 farmland being inundated in the flood cell between the

strategic 1947 line and the private 1977 Jubilee Bank line. The landowner used 1 tonne filled bags to provide a temporary defence line to prevent further sea water from entering the site. Due to land levels the water was unable to fully drain away by gravity and required pumping out. The picture below was taken on 6 December 2013, and highlights the extent of the impact.

The 2 separate breaches (each approx 30-40m wide) in the Jubilee Bank were not repaired as the land owners have decided to construct a new earth embankment (approx 300m) diagonally across the bottom corner. The work to secure their land will be completed by autumn 2014 (cost unknown).

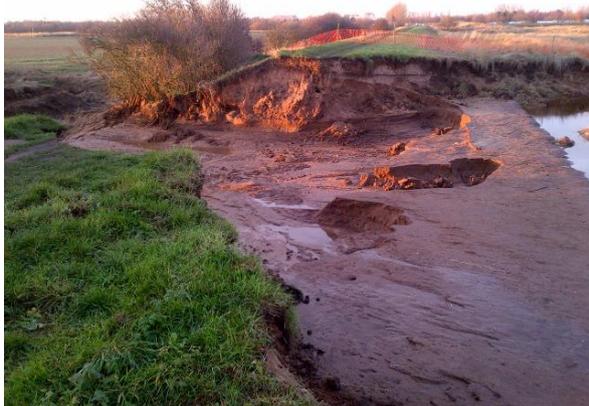
Breach on morning 06.12.13

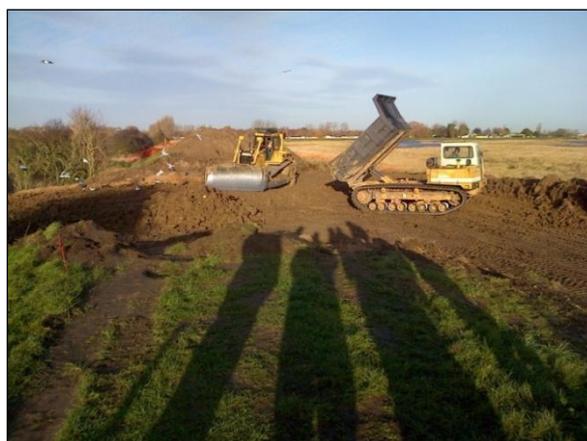
Tetney Marsh breach repairs – 20.12.13

The total cost of the repair work was £145,000.

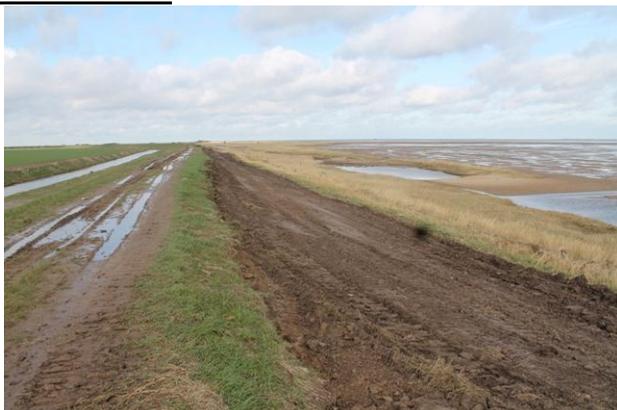
Limited repair works completed by Birse in Feb 2014

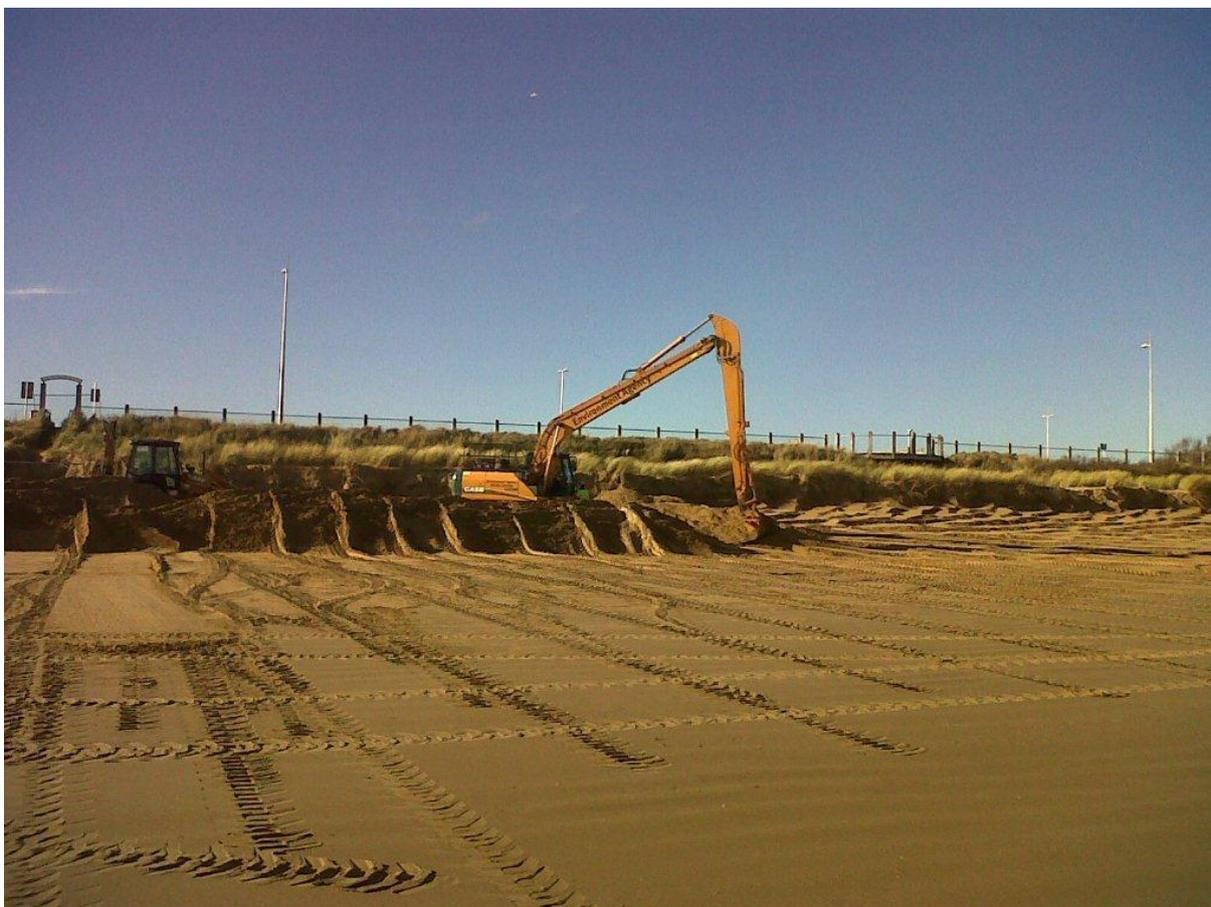
On the 6 December, the Environment Agency's emergency work force was on site to reinforce the areas most of risk, in particular the north end of Mablethorpe North Car Park and dune system (see photo below).

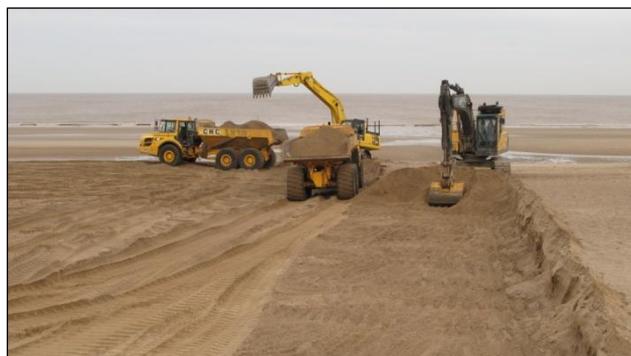
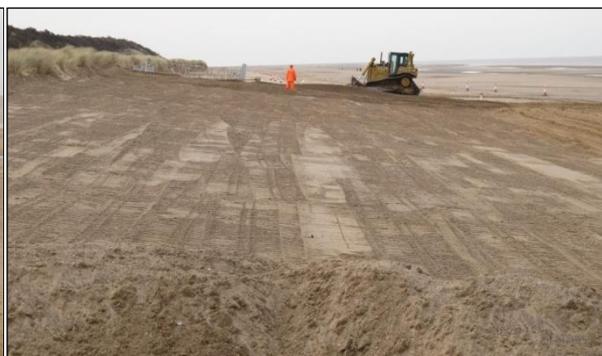
Mablethorpe emergency works

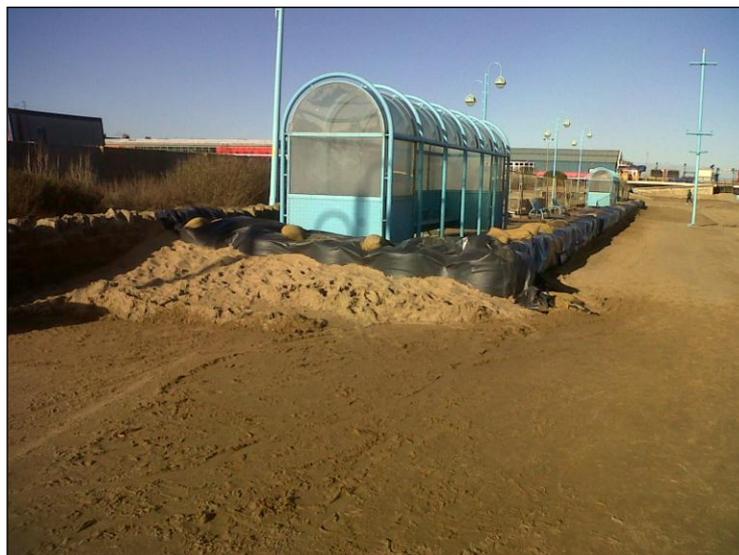
Damage to the flood wall

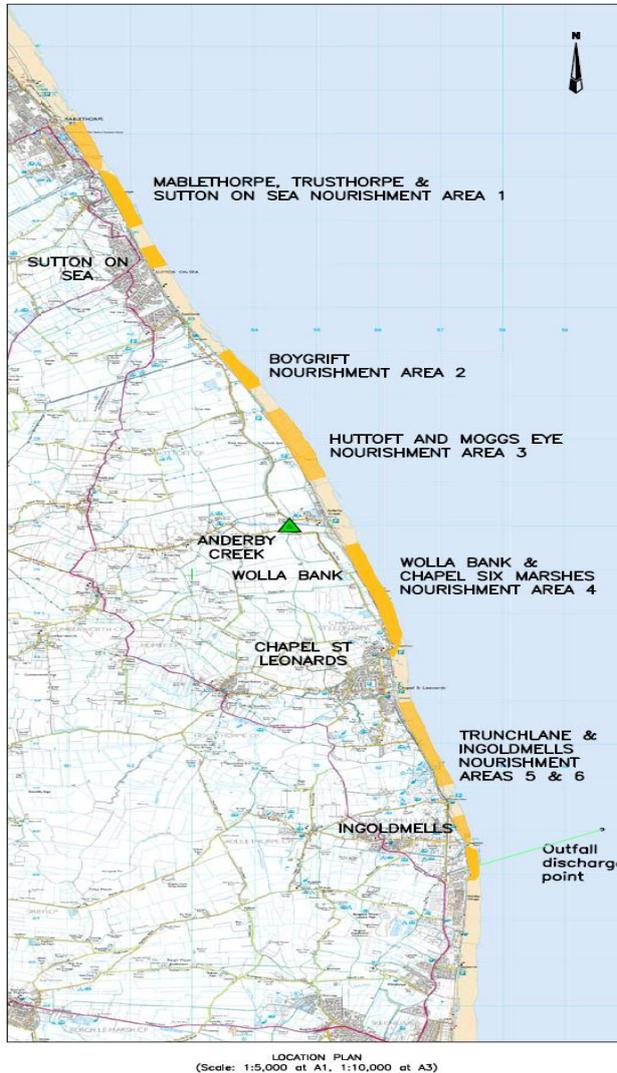
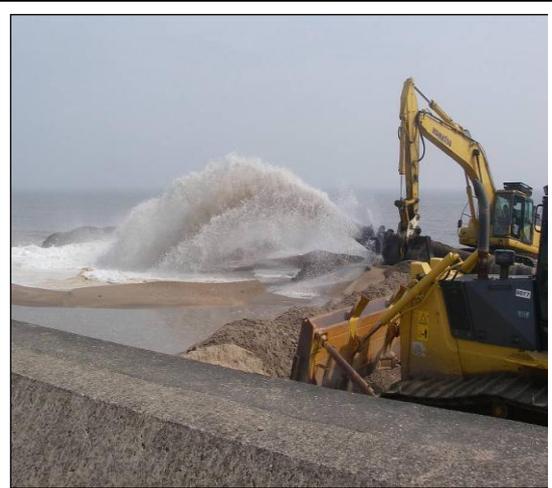
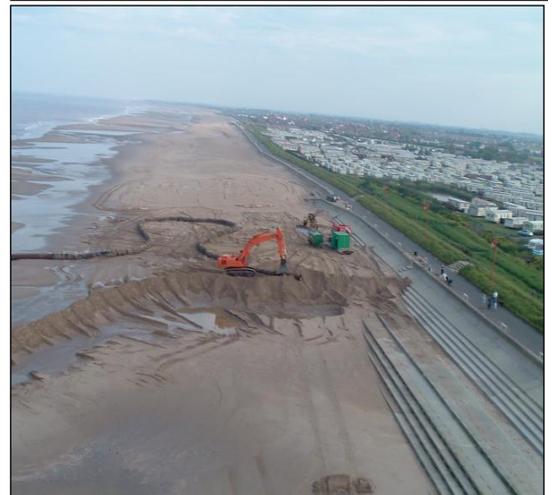
Photos of the beach re-nourishment

The estimated quantity of materials required to nourish all areas is 520,000m<sup>3</sup>

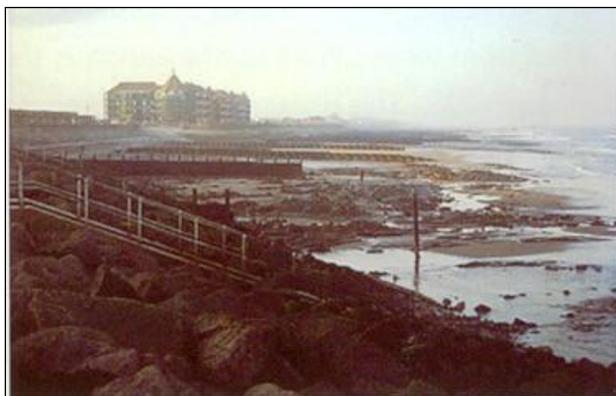
Before nourishment works in early 1990's

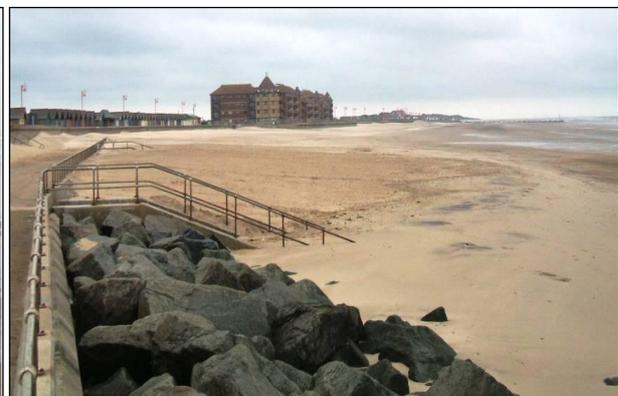
Following re-nourishment works -2009

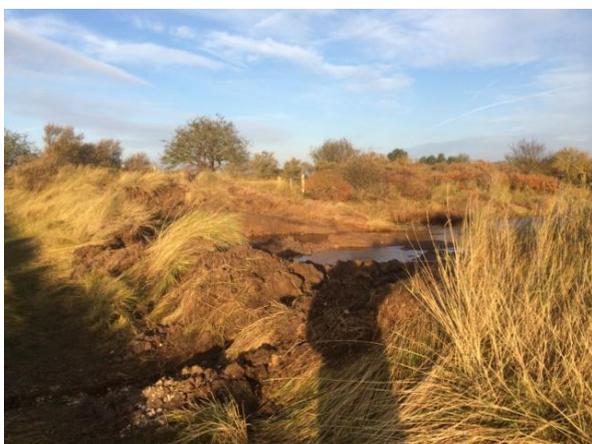
Breach point in Bulldog Bank Sluice

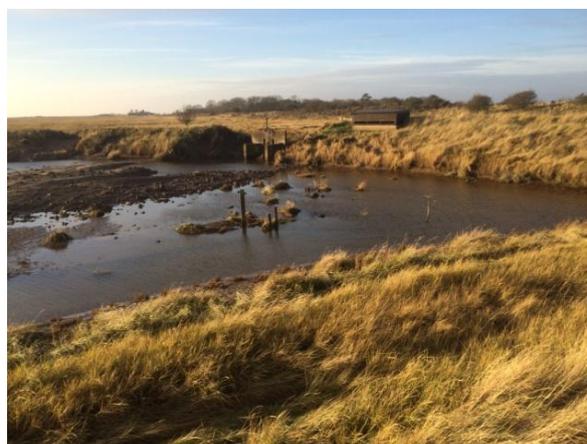
Secondary bank with sluice

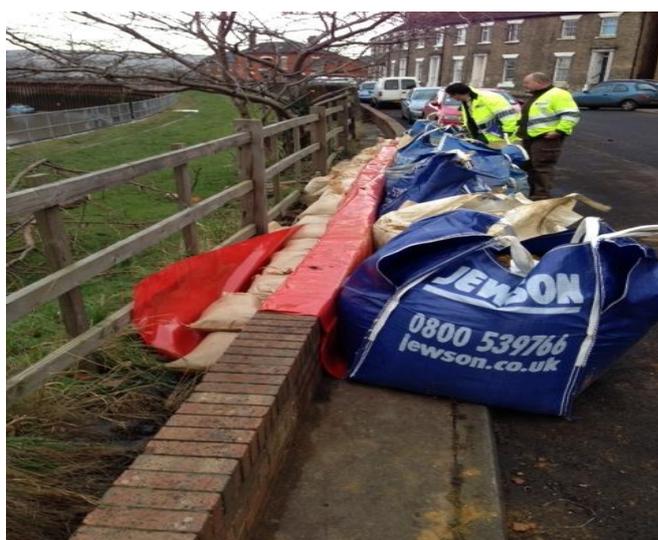
### Bath Gardens (South Terrace)

The tidal surge led to partial failure of a 10m section of a brick flood wall at Bath Gardens. Sand bags were used, not only to temporarily secure the opening, but also afterwards to protect the new brickwork against subsequent New Year high tides (cost to date £130K).

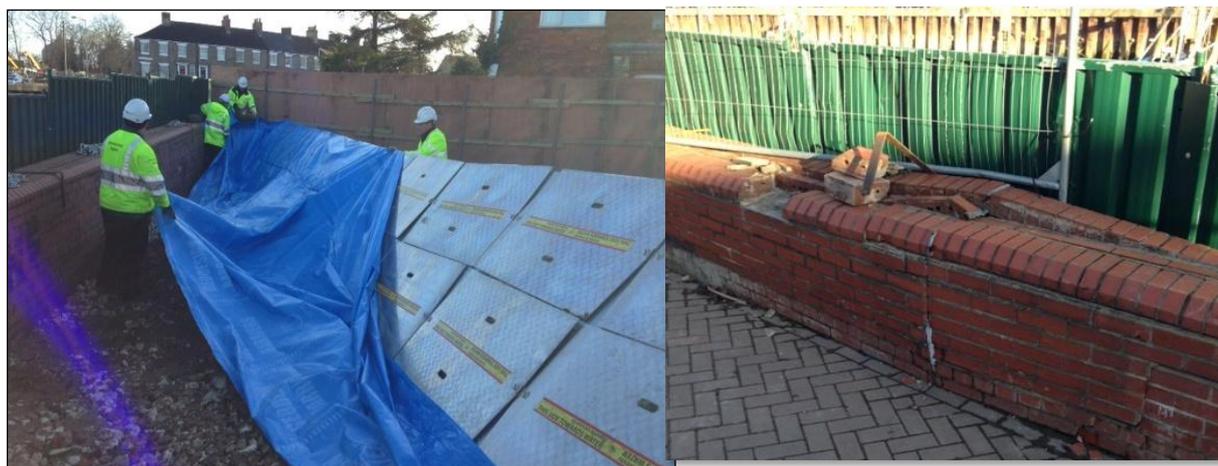
Demountable defences, White Horse Lane

Due to the impact of the high tide levels along this section of The Haven, movement of the flood wall was evident in a number of locations and a structural survey was undertaken. The flood wall was repaired along Oxford Street with a new 30m flood wall constructed at White Horse Lane. During these repair works, 1 tonne polythene sand bags were used to support and protect the existing structures from further damage during the New Year high tides. Whilst the new wall was being constructed, demountable defences were put in place to reduce the immediate risk of flooding to 150 properties in the White Horse Lane area in Boston (cost to date £1.3M).
